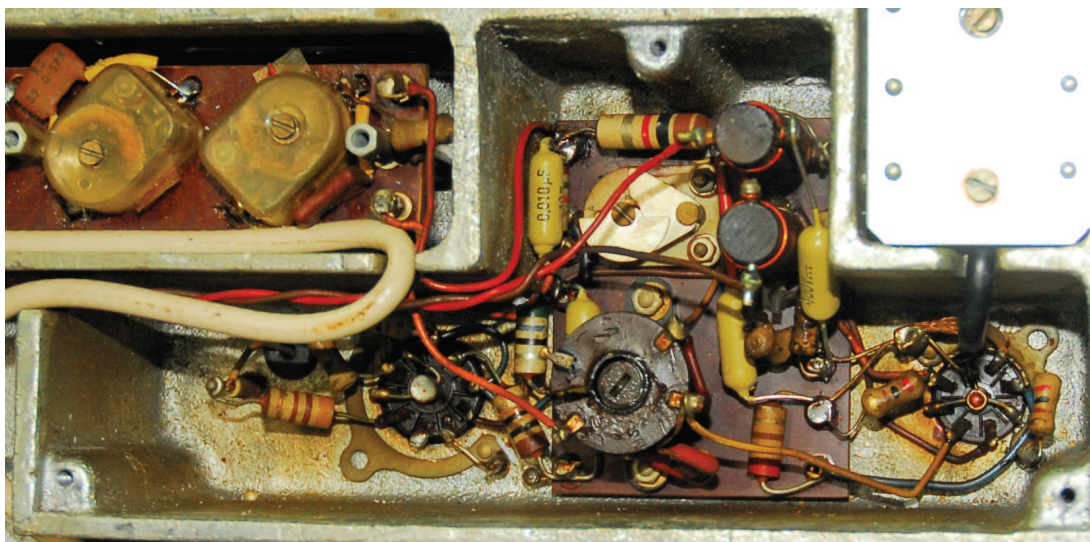
The 2nd Mixer ... This is a particularly tricky compartment to work in due to its shape. Initially I had thought that the 10nF capacitor to the left of the trimmer capacitor was wired incorrectly, but no. Due to its size (larger than the original) the 'new' one from the 1970s, was wired to a different ground terminal. However, the 1K resistor at the top came off far too easily. This metaphorically rang alarm bells. If this resistor required replacing, the most common reason would be a short-circuit trimmer capacitor drawing excessive current through the 1K resistor. I was correct. At several points on its travel, the trimmer capacitor did exhibit a short-circuit. Two things can cause this ... Either conductive debris between the vanes, or damaged vanes. The latter proved to be the case. This is likely to have been caused by a trim-tool slipping out of the slot and pressing down on the vanes. It is very likely that this is the fault which resulted in the heater choke being over-heated. Once the trimmer is damaged like this, the best approach is to simply replace it. This requires the entire tag-board assembly to first be removed from the chassis ... Not difficult but tedious due to the number of wires.

*Before*
