Racal RA17 Ser. No. N371, 4th report, 20/04/19

This is the fourth and final progress report on the refurbishment of RA17 MK1 serial number N371. Final alignment has now been carried out. This included re-shaping of the 40MHz band-pass filter and 100KHz IF filters. Several issues arose during this final stage. These have all now been resolved.

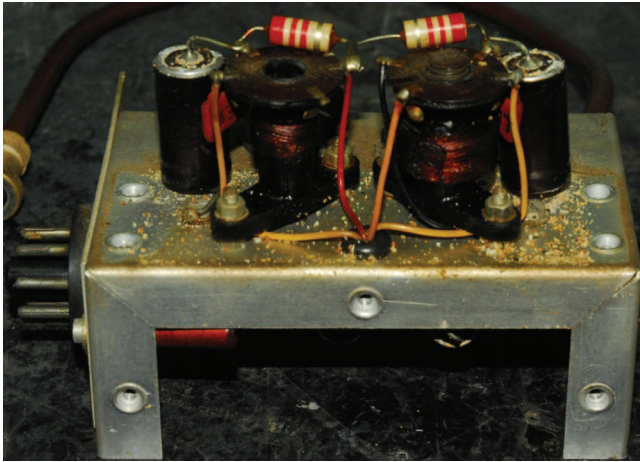
Before

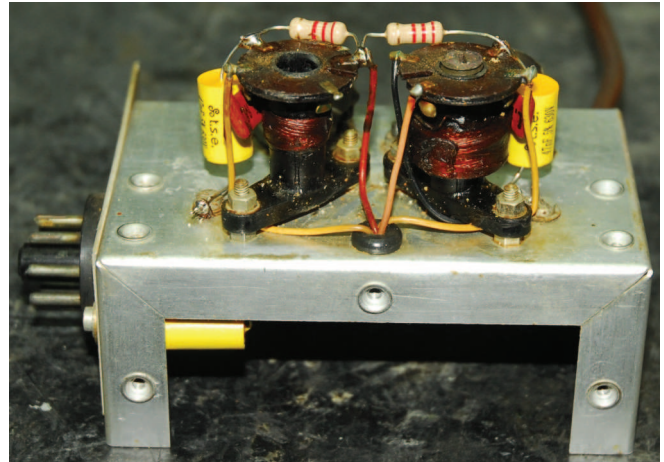
After

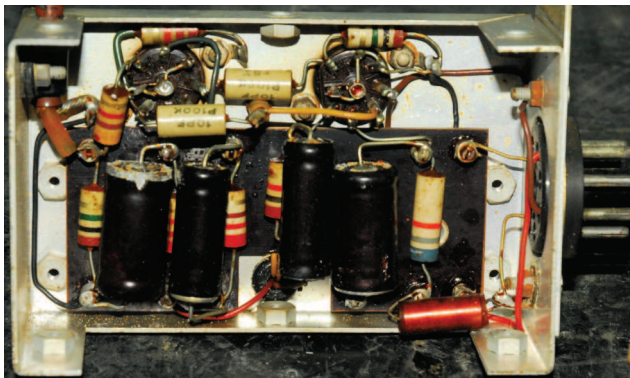
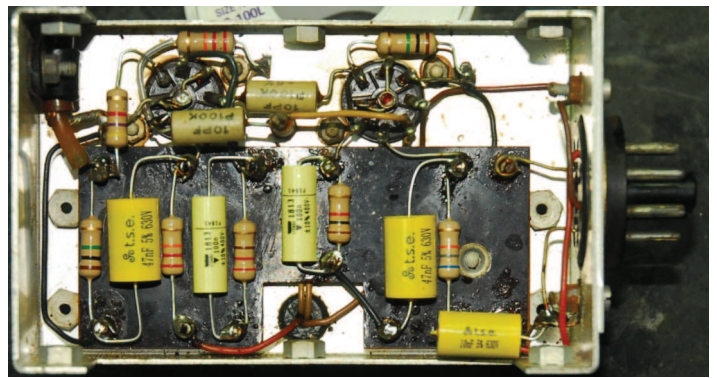
As ever, I forgot about the 'enigmatic' Calibrator. Always the first unit to be removed and the last to be refurbished! The condition of the Hunts tubular capacitors was quite bad. There was also a lot of loose debris under the top cover. This is an original MK1 Calibrator module where the bottom cover should carry a Tufnol 'foot' which rests on the top of the 1st VFO module. In this case the 'foot' was missing, so I replaced the bottom cover with one sporting the 'foot'.
