Left: I recently acquired a genuine RACAL VFO2 Test Set.

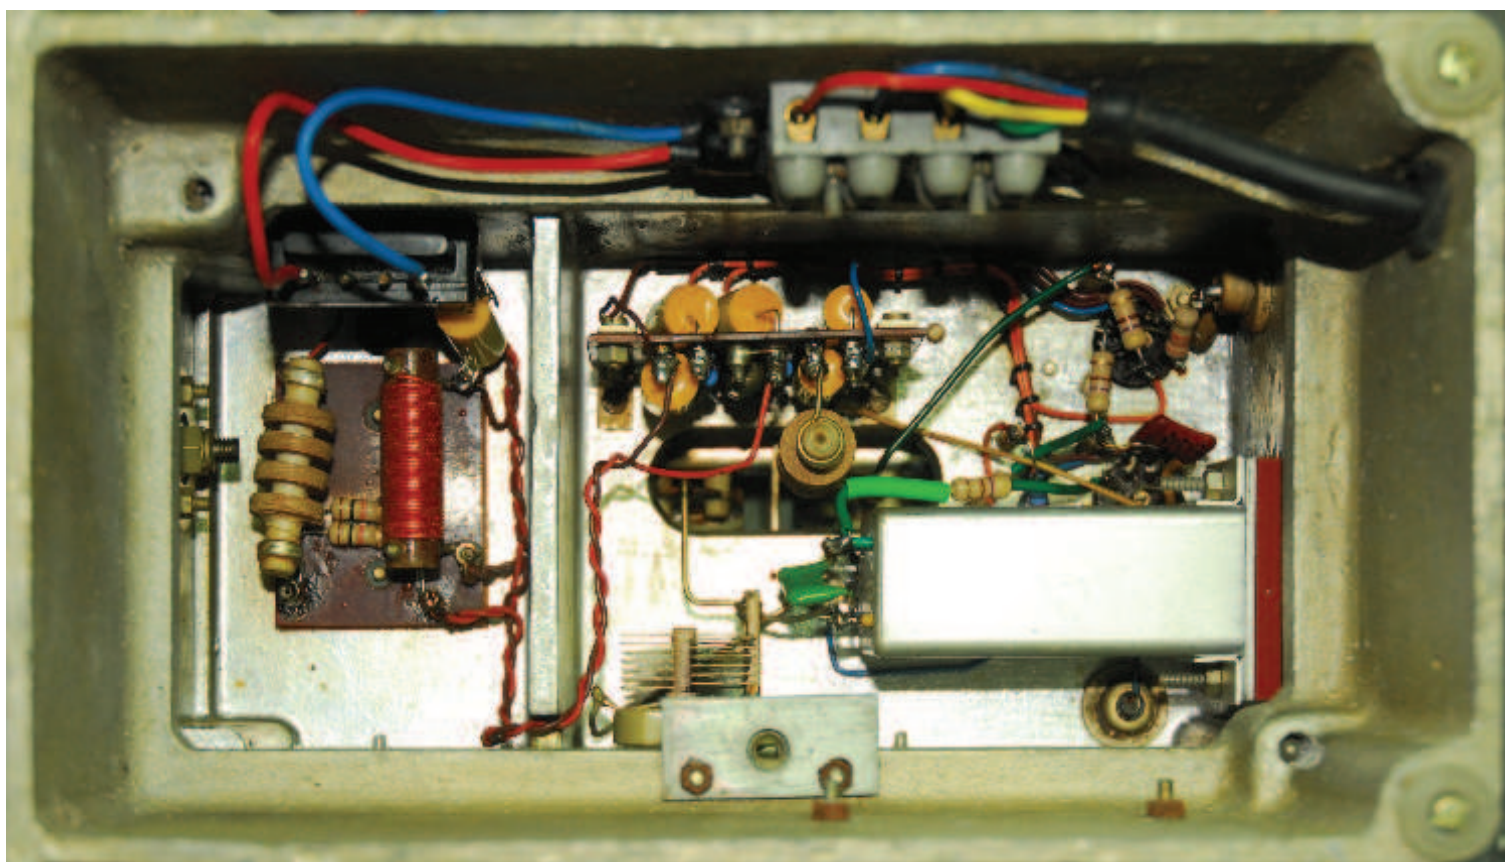
Below: The underside of VFO2 seen through the bottom of the test set. Like the PSU, this sub-assembly had likely been refurbished back in the 1970s judging by the style of capacitors used. However, all tubular capacitors and carbon resistors have now been replaced with modern components.

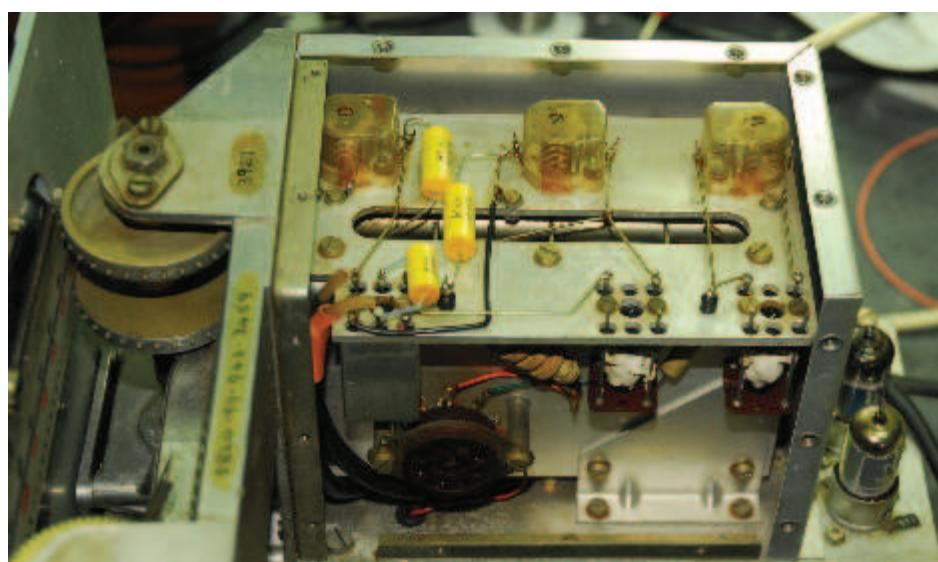
Left: the top and bottom capacitors in this photograph are safety mods. The top one serves to isolate the main tuning capacitor from HT+, whilst the bottom capacitor serves to isolate one of the rear panel connectors from HT+.
